# Asset Management Safety Bulletin: Safety Alert!

### Driller's Helper Caught in Rotating Equipment

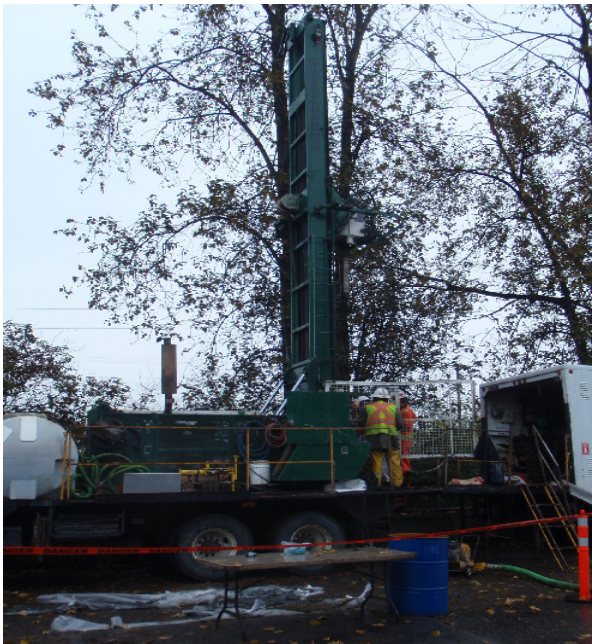
A drilling contractor sustained a first aid injury when a rotating drill pipe was being placed onto the drill head. The worker was pulled into the rotating drill equipment when their vest and clothing became caught on the drill pipe. The worker experienced bruising to the shoulder and was able to return to work and full duty after seeking medical attention.

- Proper work procedures and body positioning must be adhered to in areas with rotating or moving equipment.
- Tear-away or fitted high visibility vests must be worn by contractors and consultants at all times when on Suncor retail and wholesale facilities.
- When performing drilling operations a clear sight between the driller and workers on the platform is critical to eliminate risk to the drilling crew.
- Workers must be aware of their working surroundings including around rotating equipment to stay out of the line of fire.
