# Asset Management Safety Bulletin: Safety Alert!

## Perform Last Minute Risk Assessment (LMRA) Before Performing Tasks

### Injury from drill “Kick-Out”

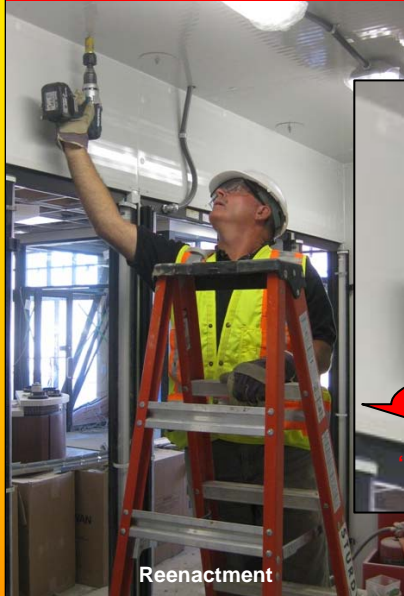
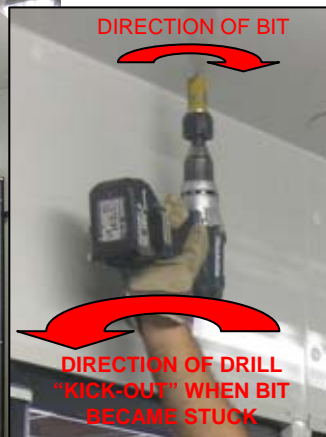
Reenactment

An Electrical Contractor was drilling a hole in the ceiling of a Walk-In Cooler using a cordless drill and a 3/4” hole-saw bit.

The bit grabbed (became stuck). The torque caused the drill to “kick-out” in the opposite direction of the bit, forcing the worker’s hand against the adjacent cooler wall, fracturing a bone in the worker’s hand.

- What may seem like a “routine task” can still carry significant risk. Perform a Last Minute Risk Assessment before performing any task and take steps to reduce the risks and mitigate potential negative outcomes.
- In this case, the drill could have been angled so that the battery pack was closer to the wall to reduce the amount of kick; the drill could have been set to a lower speed to reduce the velocity of the kick; body position could have been improved - less arm extension/more bend in the elbow to provide more control over the tool.
- Had the hole been further from the wall, this type of incident still could have resulted in an injury to the wrist/arm. Drill kick-out has also contributed to abrasions in the past.
